TECHNICAL BULLETIN

MS-5UD and MS-10UD

October 10, 2007

Document FLTB07-10-01

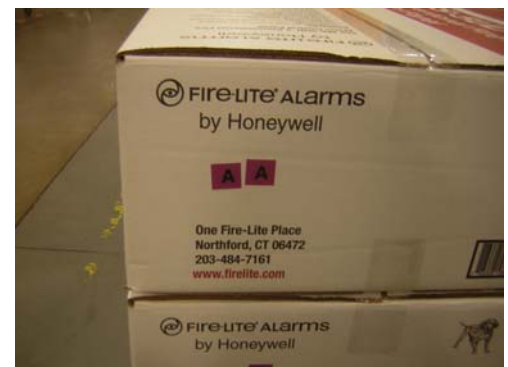
The MS-5UD and MS-10UD are now shipping with this updated version of software installed. Customers can determine if their shelf stock contains the updated software as it is identified by a purple date code stamp with two A's (AA) instead of just one (See carton photo below).
